Hydrogeomorphological investigation of the main streams feeding into and out of Loweswater

Client

Lancaster University, The National Trust

14th May 2010

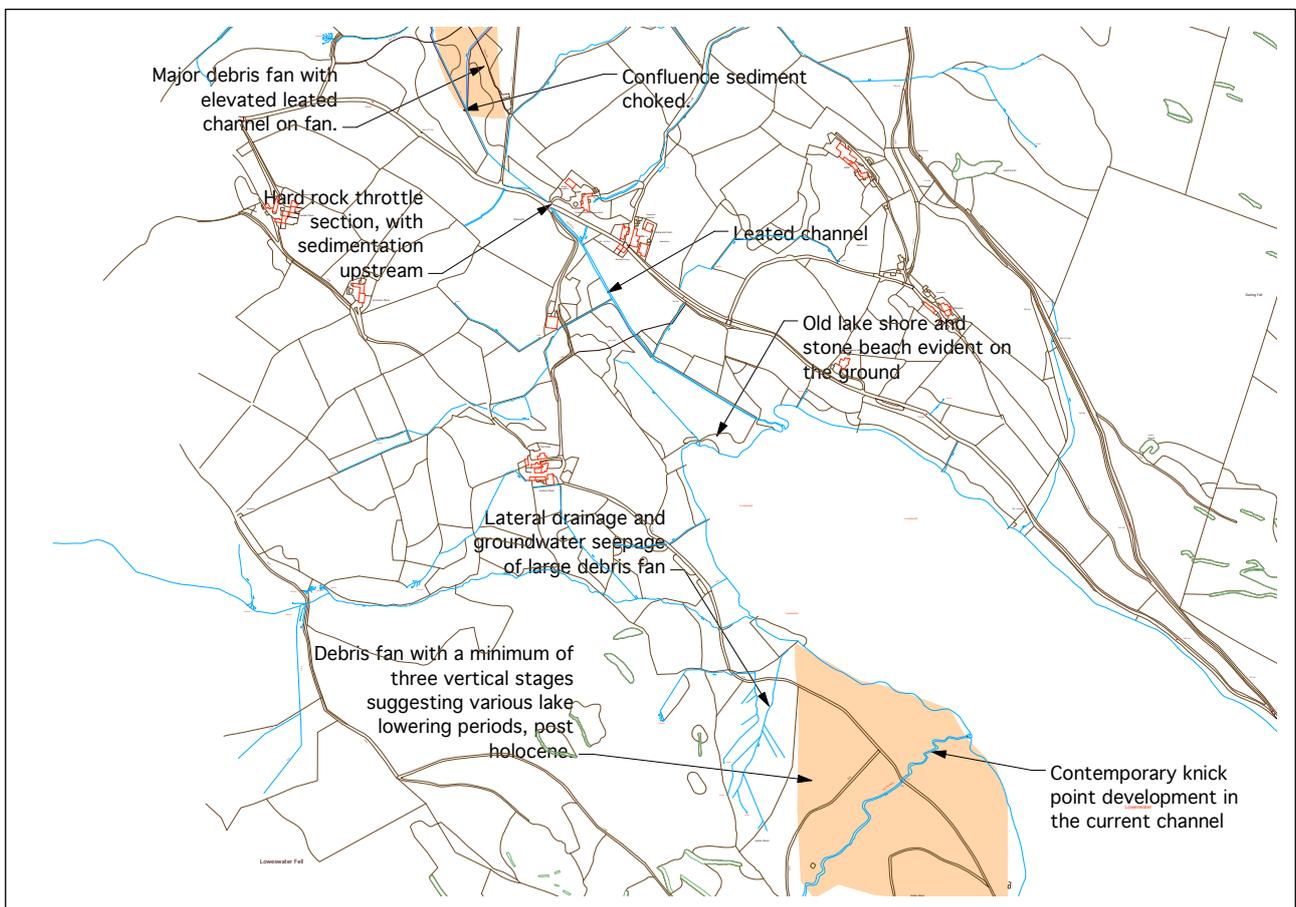
Figure 2: Annotations on Main Geomorphological Features - Dub Beck

In the comments below, a key tributary of Dub Beck named Whittern Gill (flowing near Graythwaite, figure 1) is of key interest. The lower section of this Beck flows over an active debris fan and the elevation of this channel and the state of the confluence of this Beck with Dub Beck is of concern (figure 2).

Holme Beck, which drains Burnbank Fell, represents a semi natural channel form, especially above Holme Force. Below Holme force the channel has small levels of channel intervention works (revetment) but the main feature is that the channel flows over a large debris fan associated with the erosion of the high level moraine material in Holme Beck valley above the Force (waterfalls, figure 2).

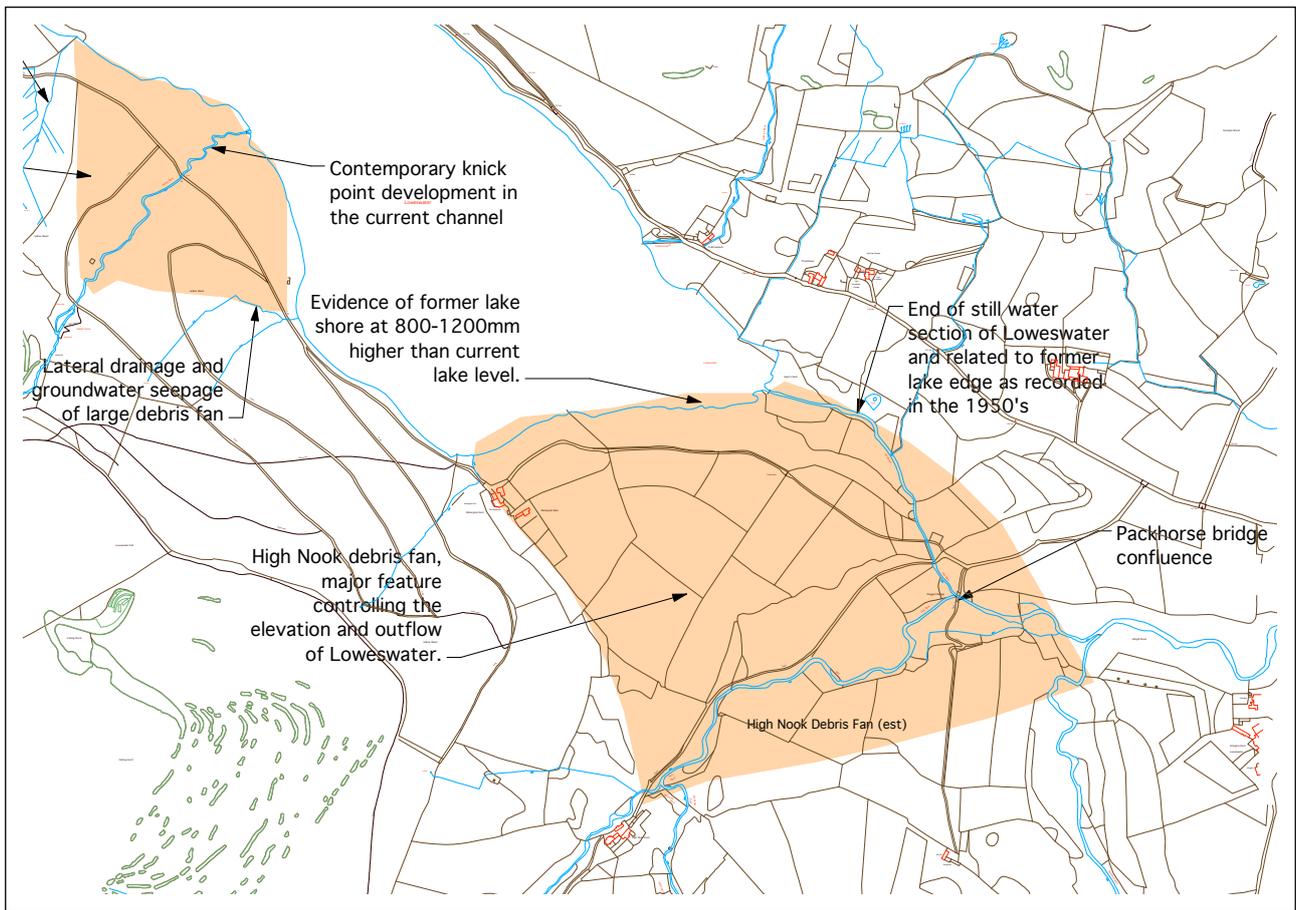
Figure 3: Annotations on Main Geomorphological Features - High Nook

Highnook Beck rises on Lamplugh Fell and flows past High Nook farm building before joining Dub Beck just upstream of Maggie's Bridge. Below High Nook Tarn, the channel enters a deep incised valley associated with erosion of moraine material. This eroded material has formed an extensive debris fan, which start locally to High Nook farm and spreads westwards to Loweswater and eastwards and down to Maggie's Bridge. On the surface of the debris fan are a number of relic channel suggesting that Highnook Beck in the past had a more direct route to Loweswater, but this channel now flows on the eastern side of the debris fan. Joining Highnook Beck is Whiteoak Beck. This valley was not walked in October 2009, but the sediment supply from this valley system appears to have contributed to form the large debris fan that now exists at the southeastern end of Loweswater (figure 3).

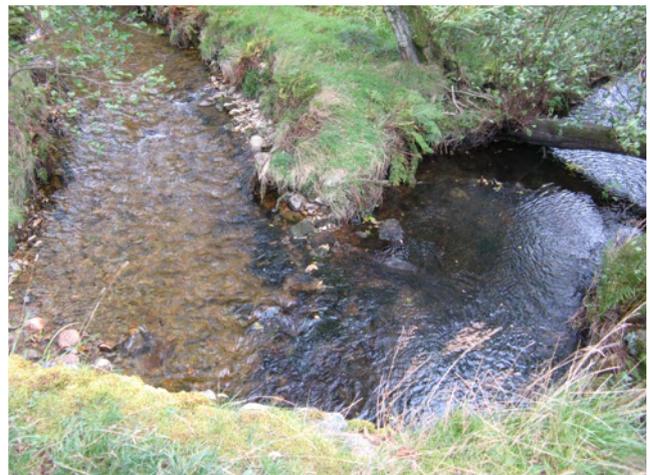
Figure 4: Image of Highnook Beck (left) and Dub Beck (right) confluence at Maggie's Bridge, October 2009.

The sediment supply was Highnook Beck seems the largest source of material movement in the valley complexes visited. Figure 4 shows the channel becks of Highnook and Dub's Beck at Maggie's Bridge. Highnook beck seems to be frequently scouring its bed not allowing any algae or benthic vegetation to establish, while Dub Beck (right of image) shows mature benthic algae accumulation on the stream bed.

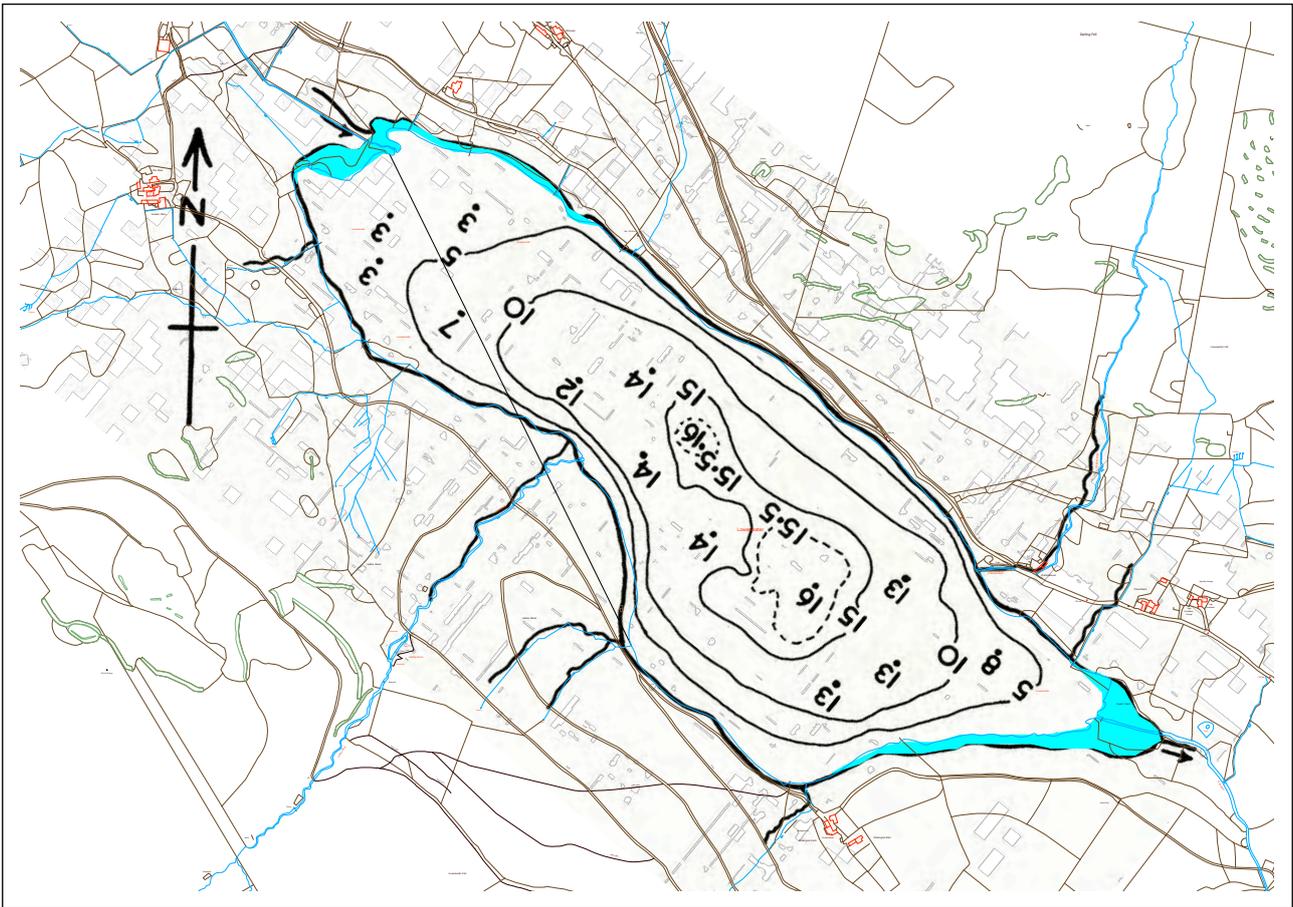
Figure 7: Bathymetric Map of Loweswater 1937-1938, Ramsbottom A.E. (1976). Depth charts of the Cumbrian Lakes. Freshwater Biological Association Scientific Publication No. 33. Titus Wilson & Son Ltd. Kendal. Areas in solid light blue show areas where lake shore differs between 1938 and 2009.

In figures 5-7, maps have been collated that seem to suggest that post 1938 the water level in Loweswater was lowered, resulting in the current shoreline being mapped in a different location, especially in the south east and north western shoreline. The bathymetric survey of 1937-1938 and also OS maps prior to 1930 suggest that lake levels may have been 0.5-1.0m higher than the current location with the lake area reducing from 64 hectares to 61.3 hectares. This lowering may have reduced the lake volume by 7%, from an estimated 5.4 million cubic metres to 5.02 million cubic metres.

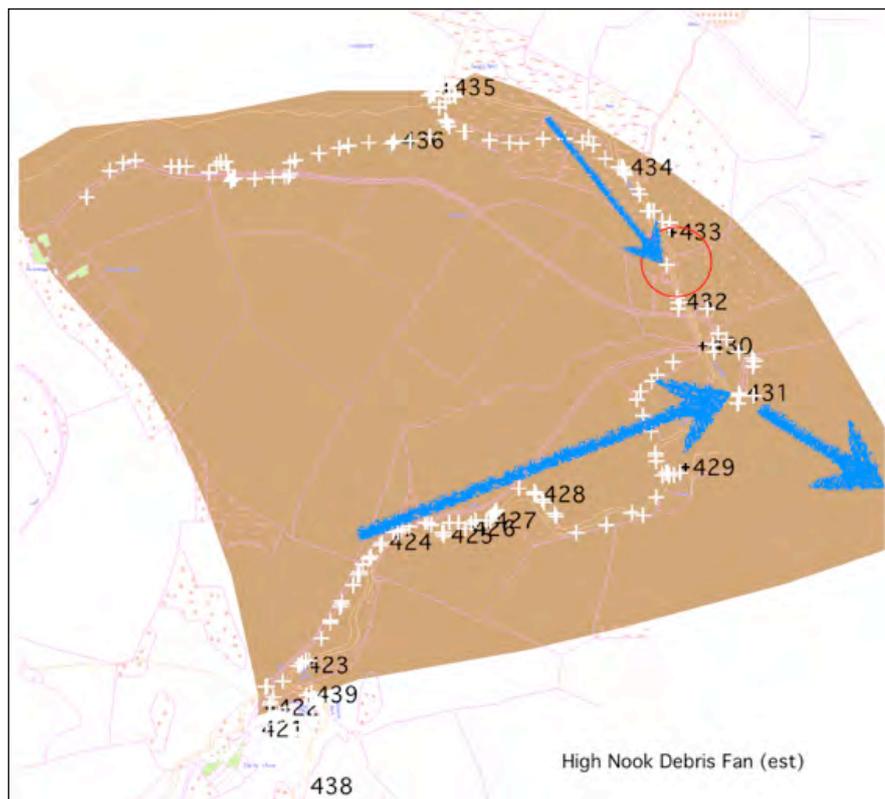
Figure 8: Annotated map of Highnook Beck and its dominance of Dub Beck, discharging from Loweswater at the northern perimeter of Highnook Debris Fan (shaded in tan).

3. The possible lowering of Loweswater and the channelisation of Dub Beck along the perimeter of Highnook Debris fan (figure 8) further supports the dominant role that Highnook plays in the flows from Loweswater. If high sediment loads from Highnook block the channel at Maggie's Bridge, then water levels in Loweswater is rise.

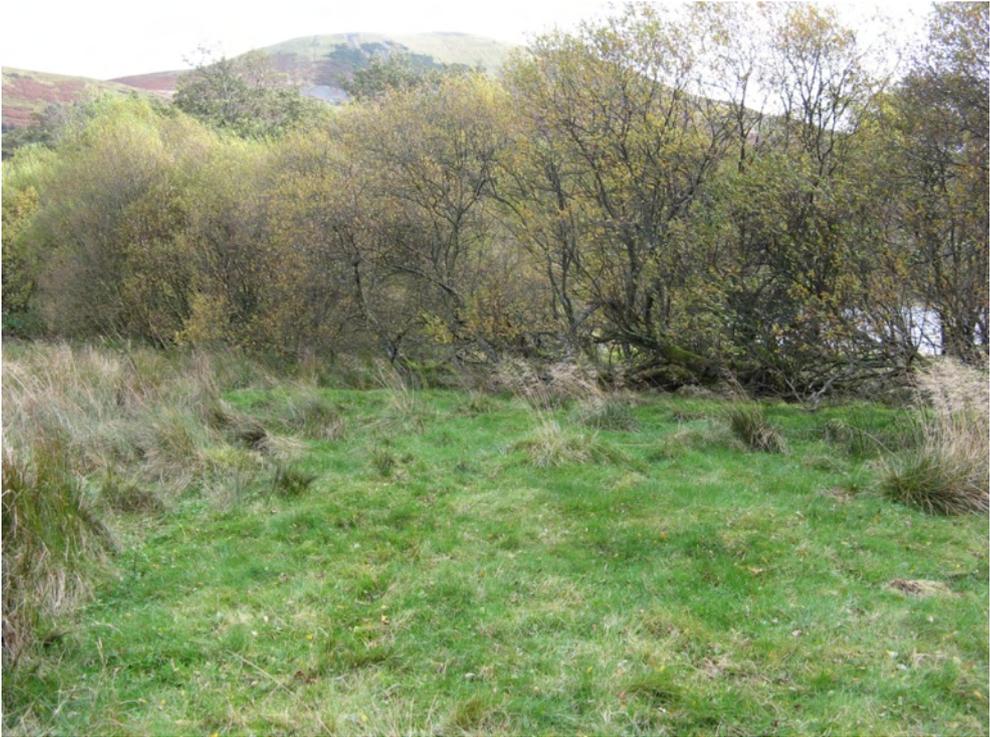
Figure 9: Image of former shoreline at Dub Beck floodplain in the north western section of Loweswater.

5. At the north western end of Loweswater, Dub Beck has been extensively channelised, but evidence of a former shoreline is present in the current sedge mire (figure 9).

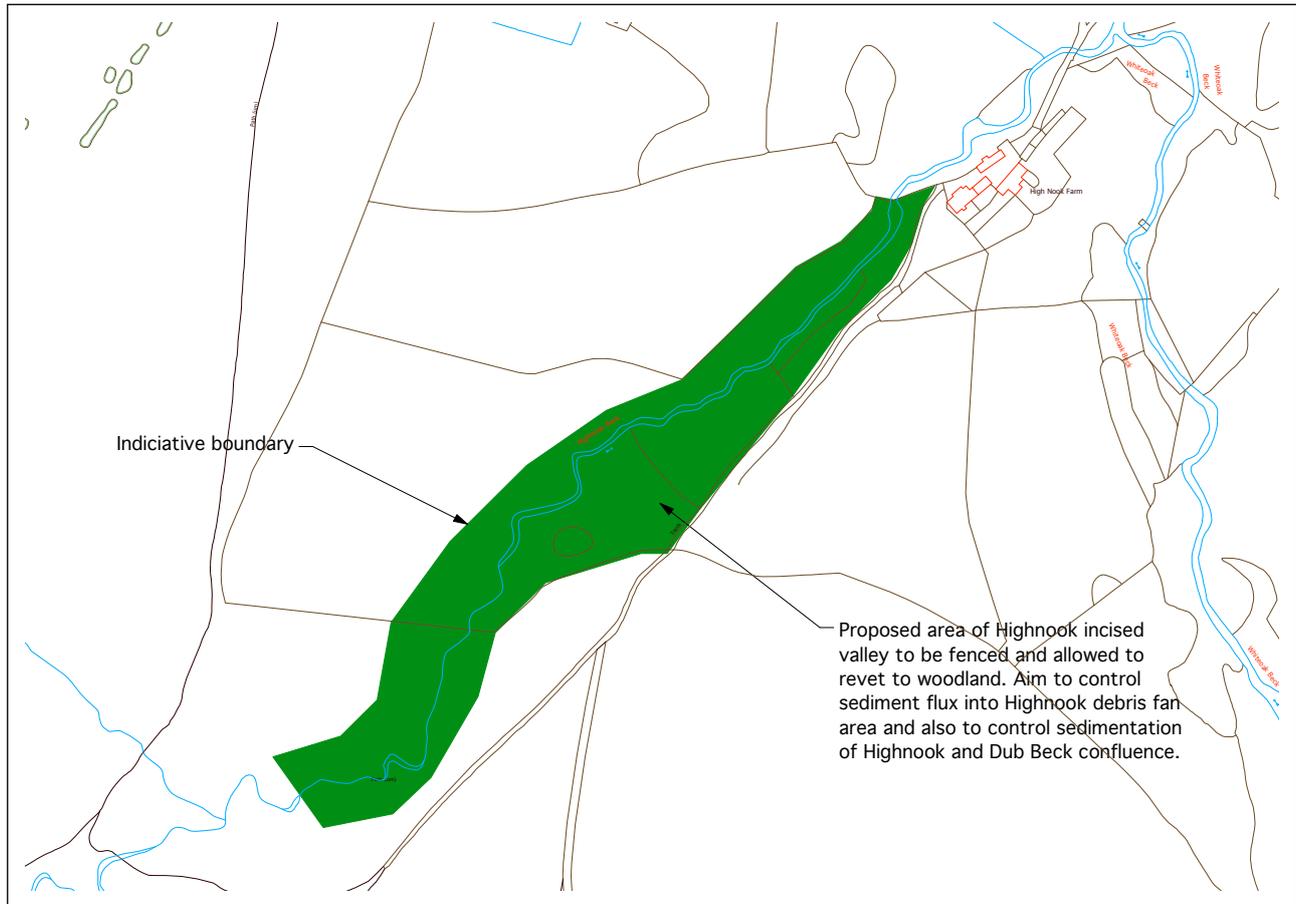
Figure 13: Annotation of options to reduce sediment supply from Highnook Beck.

The sediment supply and incised valley erosion in High Nook Beck needs to be controlled as the rate of sediment supply seems excessive, with stream bed erosion downstream accelerating. The current valley is used to herd sheep to Highnook farm, and the fencing of the valley needs to be associated with creating an effective livestock route to the farm and associated holding areas. The fencing of these features, as undertaken in Wharfedale (Yorkshire Dales) by the National Trust resulted in 80% of the sediment supply to the main river being reduced. Therefore we would recommend this option to the National Trust.

6. The fencing of the incised Highhook Beck valley needs to be strongly considered, in order to reduce sediment supply to the lower sections of the channel, before Maggie's bridge.
