Hydrogeomorphological investigation of the main streams feeding into and out of Loweswater

Client

Lancaster University, The National Trust

14th May 2010

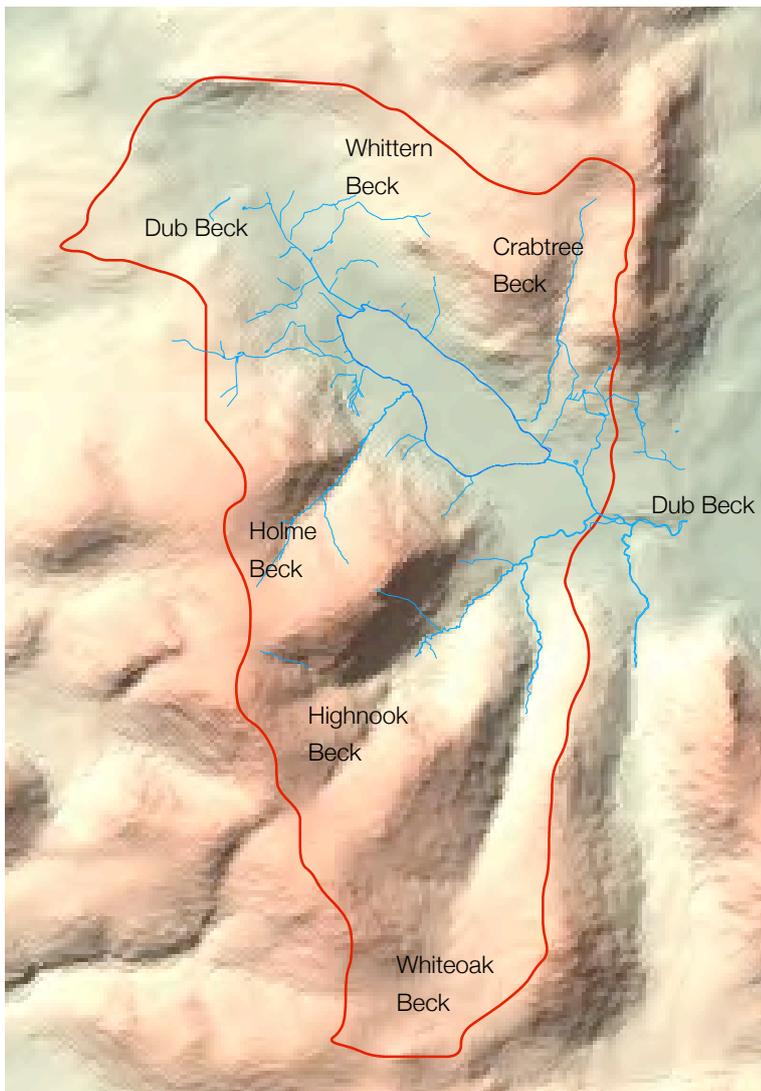
Figure 1: Loweswater Catchment Boundary

Loweswater catchment is illustrated in figure 1 (below). The total calculated area of the catchment, based on OS digital terrain data held by the National Trust, is 14.0 km-sq. For the purposes of this report, we have assumed that the catchment consists of Dub Beck (NW basin), Holme Beck (SW basin and discharged into the mid point of loweswater), Highnook Beck (SSW basin and discharges downstream of lake, but debris fan aquifer is assumed to feed Loweswater), Whiteoak Beck (S

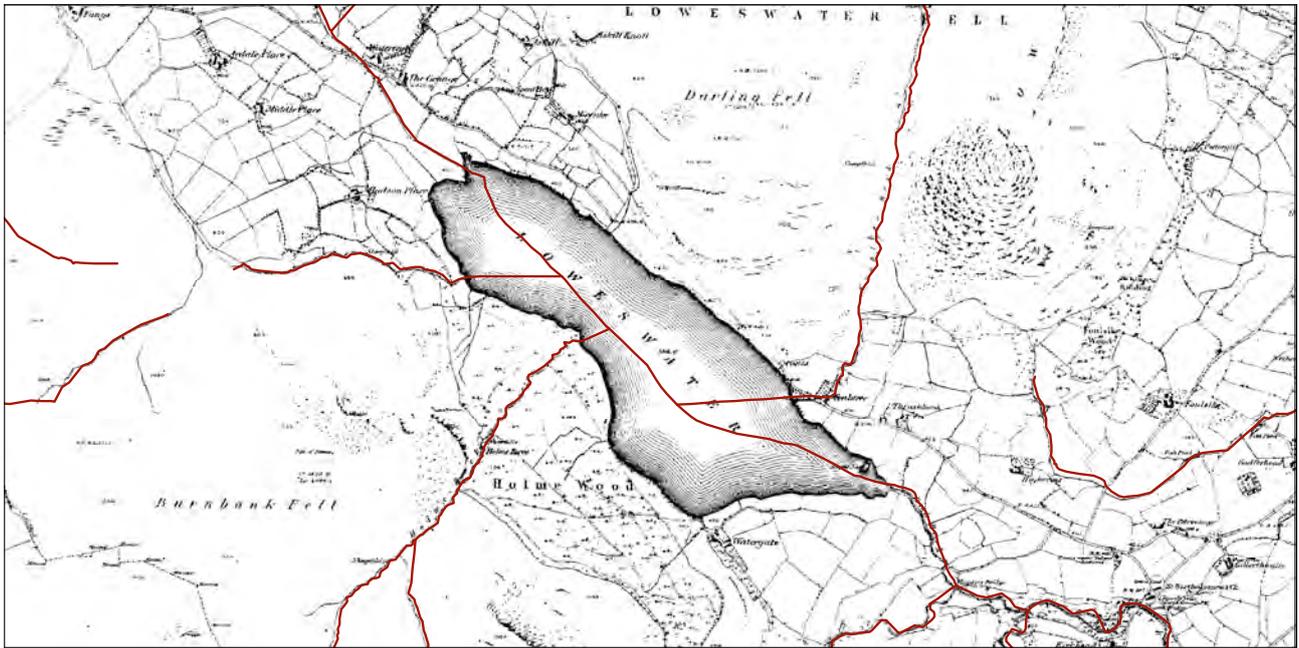
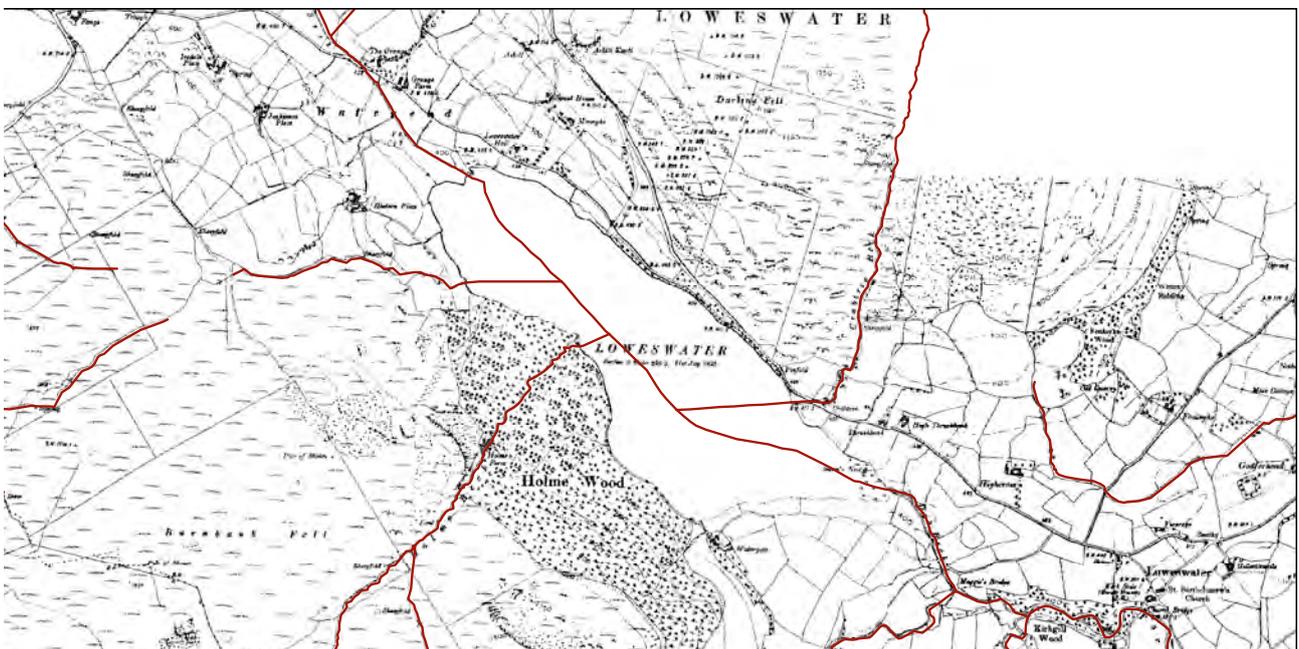
Figure 5: First Series OS map of Loweswater, c. 1860

In figures 5-7, maps have been collated that seem to suggest that post 1938 the water level in Loweswater was lowered, resulting in the current shoreline being mapped in a different location, especially in the south east and north western shoreline. The bathymetric survey of 1937-1938 and also OS maps prior to 1930 suggest that lake levels may have been 0.5-1.0m higher than the current location with the lake area reducing from 64 hectares to 61.3 hectares. This lowering may have reduced the lake volume by 7%, from an estimated 5.4 million cubic metres to 5.02 million cubic metres.

If there was an intension to raise the water level of Loweswater to the estimated levels prior to 1938, then it is recommended to undertake this through the use of a small check weir (or series of weirs with <200mm steps, figure 12). This weir would be served by a new smaller outflow channel, which would throttle the flow of water from Loweswater thereby allowing a more natural water level regime to be introduced into the lake.
